PRELIMINARY REPORT

HIGHWAY

HWY19FH008

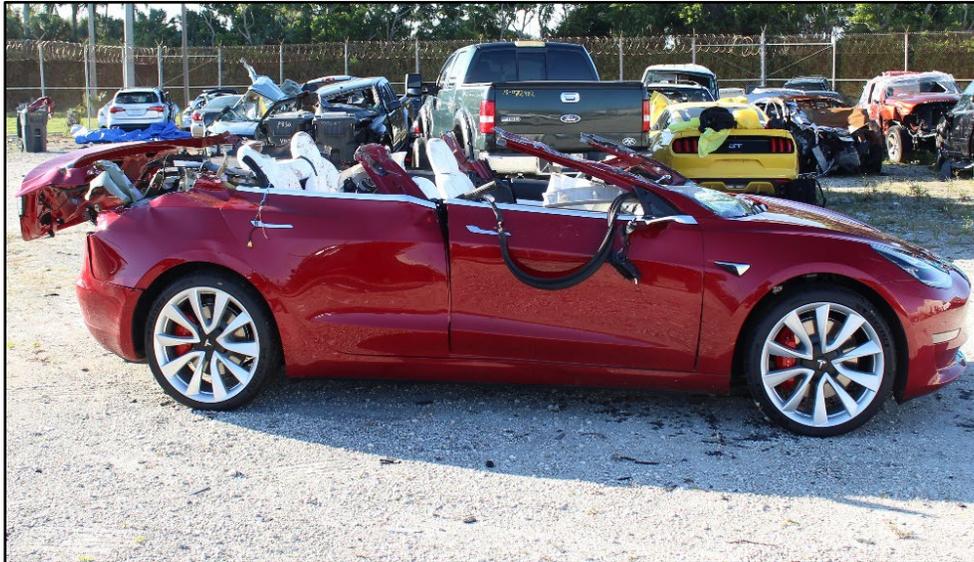
The Tesla struck the left side of the semitrailer. The roof of the Tesla was sheared off as the vehicle underrode the semitrailer and continued south (figure 2). The Tesla came to a rest on the median, about 1,600 feet from where it struck the semitrailer. The 50-year-old male Tesla driver died as a result of the crash. The 45-year-old male driver of the combination vehicle was uninjured.

Figure 2. Tesla Model 3 with extensive roof damage photographed postcrash at tow yard.
