PRELIMINARY REPORT

HIGHWAY

HWY19FH008

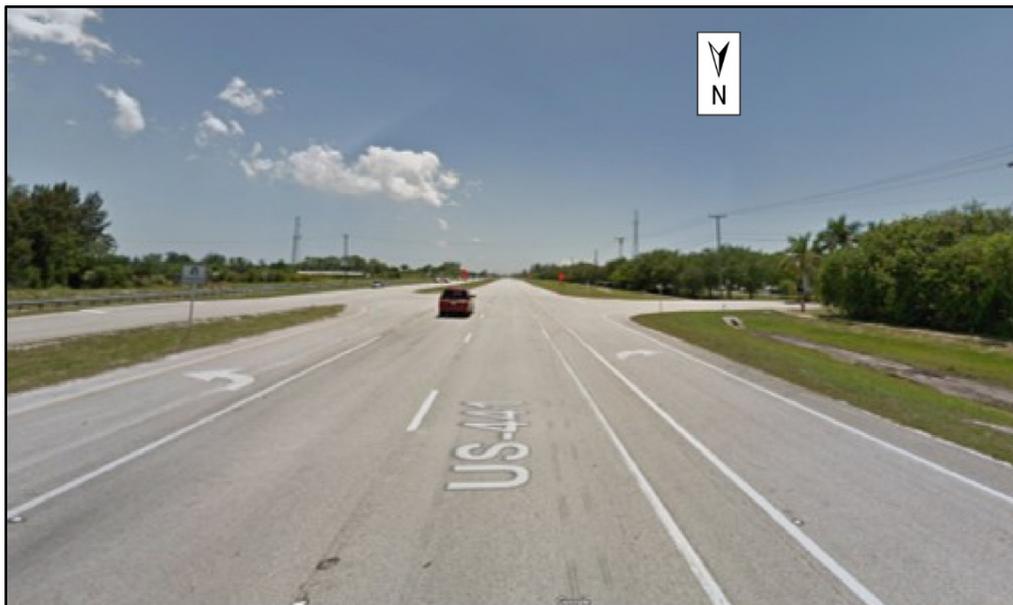
Figure 1. Southbound view of crash intersection. Private driveway into agricultural facility is visible on right side of image. (Source: Google Maps)
